Test report No.: 184000084

Test name: Test of hydraulic properties

Subject of testing: IPS Kalyxx BlueLine

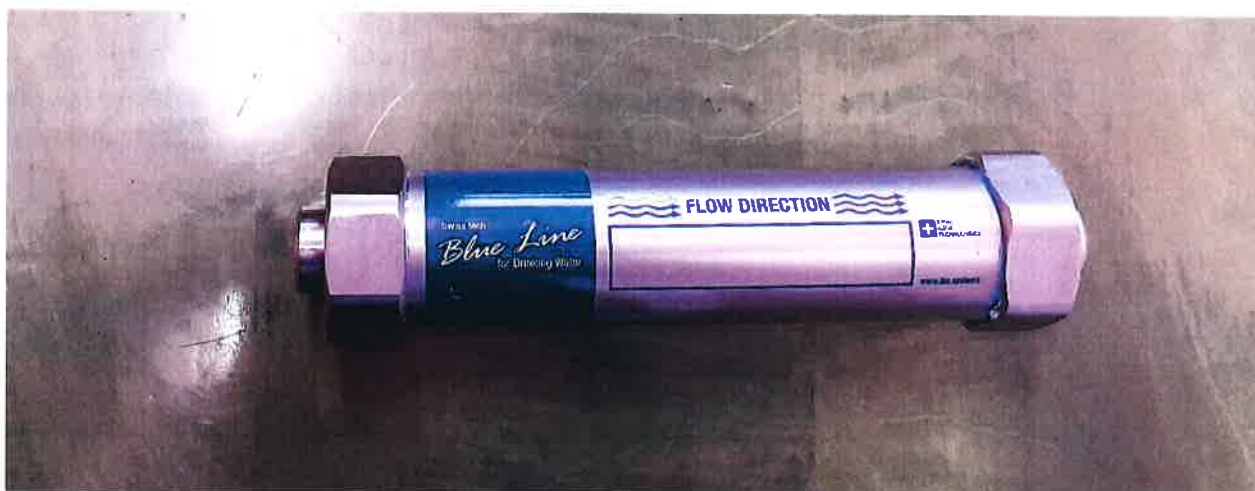
Picture 1 IPS BlueLine

The device is designed for the physical treatment of water. Prevents formation of limescale and corrosion. It also helps to remove them. IPS can be installed in closed and open dynamic systems.

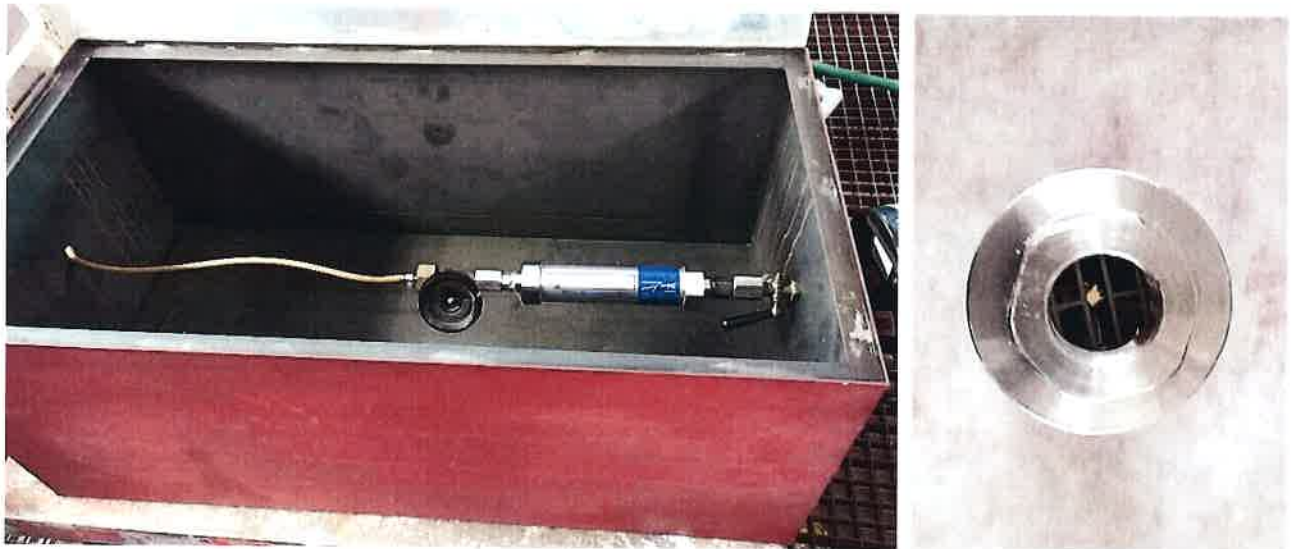
Picture 2 IPS BlueLine in the test cabinet and during distance measurement.

The target of strength test was verifying that the product is capable to resist pressure of 1, 5 and 10 MPa. Another requirement was to measure (before and after the test) the distance between the inner component (propeller) and the inlet and determine if there is deformation effects during the test.

The product was clamped in the test cabinet and subsequently exposed to the required pressure.

During the test, the product showed no signs of damage and no leakage was detected. The distance between the center of the first component and the input section remained unchanged – 32,3 mm.
